# Manhole Inspection Summary

Manhole # **S17GG\_024MH**

Insp Date: **6/12/07 10:07 AM**

**Location** Address: **2203 BAKER ST**

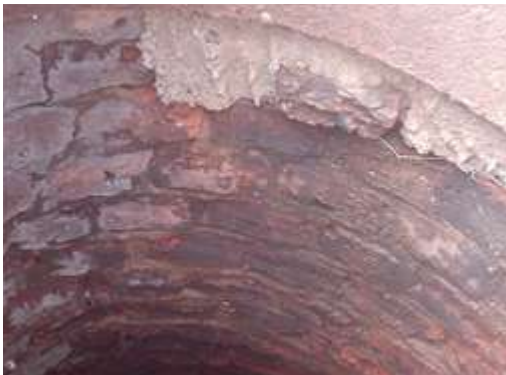
Defect 4

Infiltration: ☐ None ☒ **Joint** ☐ Cracks ☐ Mortar ☐ Roots ☐ Wall

INFILTRATION OF CORBEL

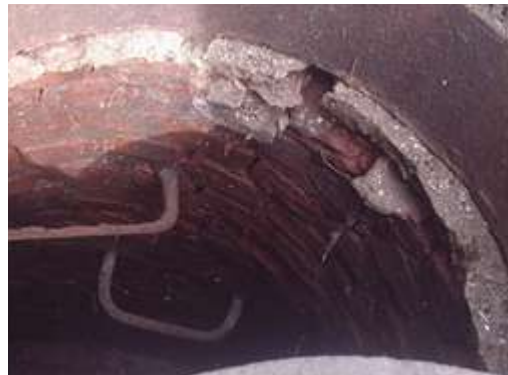
Defect 3

Condition: ☐ Sound ☐ Cracked ☐ Root Intrusion ☐ Loose Brick ☒ **Deteriorated**

DETERIORATION OF CORBEL AND CHIMNEY

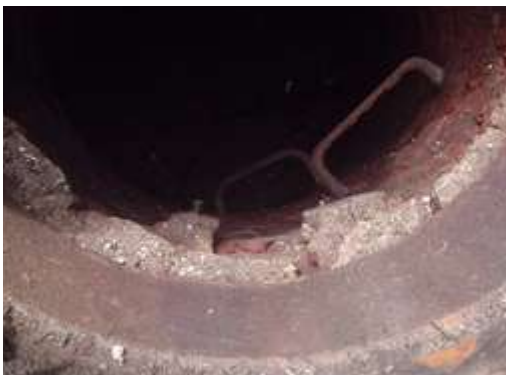
Defect 2

Offset: **2** (in.)

FRAME OFFSET

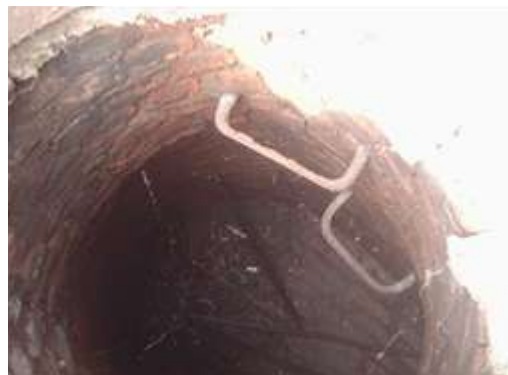
Defect 1

Count: **2** Missing: **1** ☒ **Corroded**

MISSING AND CORRODED STEPS

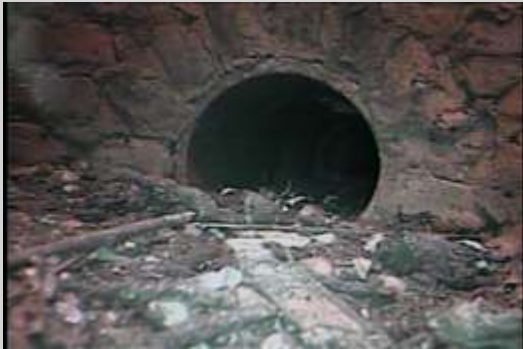
12 O'Clock Outflow

8 in. Circular Gravity Sewer  
Pipe Out @ 12 O'Clock

Deposits: ☐ None ☐ Mud ☐ Sludge ☒ **Debris** ☐ Grease

Silt Depth: **2** (in.) Deposits Extent: **Medium**
